# Analysis Damage Cylinder Head Engine on QSK 50 MCRS

Hamka Munir, Ismail Ramli and Misdar Alamsyah

*Nunukan State Polytechnic, Heavy Vehicle Study Program, Jl. Ujang Dewa, Nunukan, Indonesia*

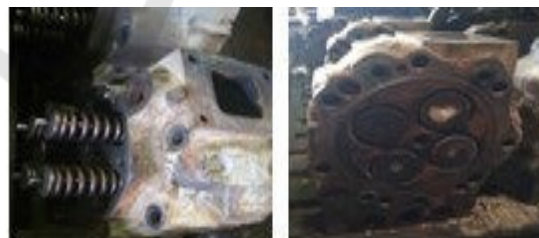
From initial observations made on the QSK 50 MCRS cylinder head engine, it shows that the hour meter unit is 14,000 HM. The cylinder head is damaged on the surface of the combustion chamber, due to erosion.

Figure 2: Corrosion on cylinder head.

During the process of dismantling from the cylinder head on the QSK 50 MCRS engine. Actually, evidence was found that the right side of the combustion chamber surface was eroded. Therefore the cylinder head must be disassembled and then re-inspected to ensure the actual specifications on the cylinder head.

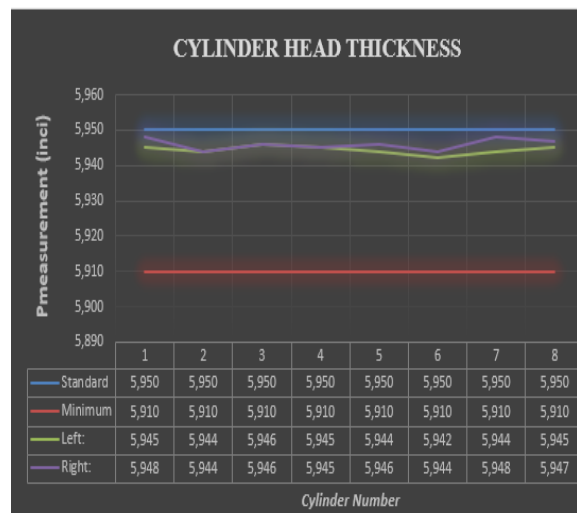
This measurement is done so that the results obtained can be compared with the manual and to detect damage visually. Because damage to this area can have a major impact on engine performance. The impact of damage to this area includes compression compression, the entry of oil into the combustion chamber, which results in incomplete combustion. In the measurement step, a digital caliper is used. The measurement results can be seen in the image below. Based on the data in Figure 5, the cylinder head thickness still meets the standard measurement results are still above the standard because the cylinder head thickness is minimum.

Figure 5: Cylinder head thickness measurement results.

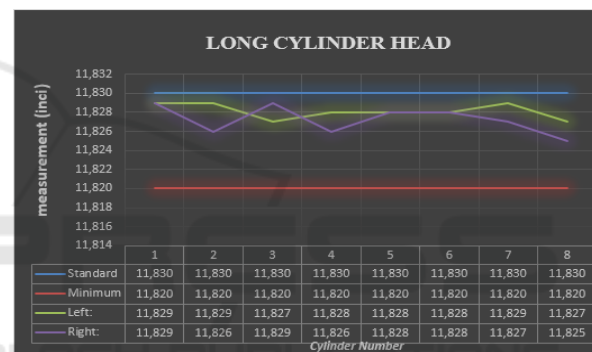
Figure 6: Cylinder head length measurement results.

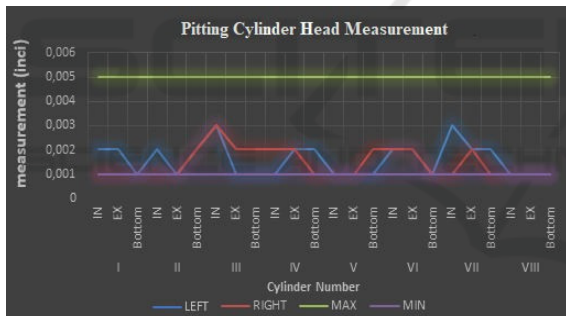
Figure 8: Pitting measurement results on the cylinder head.

Figure 8 shows the results of pitting measurements on the cylinder head. The measurement results indicate that the cylinder head still meets the standard and can be reused, the hole measurement value is still below the maximum value.

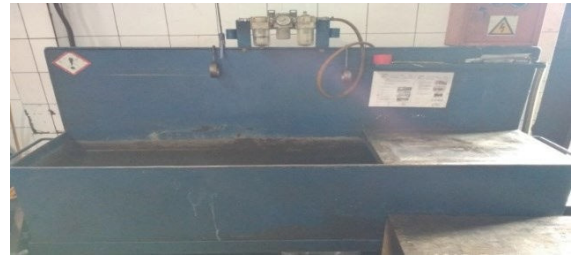
Figure 9: Tank pressure test.

After testing, the results showed that there was no leakage at the orifice valve. In addition to the pressure test, a visual inspection of the cylinder head is also carried out to check:

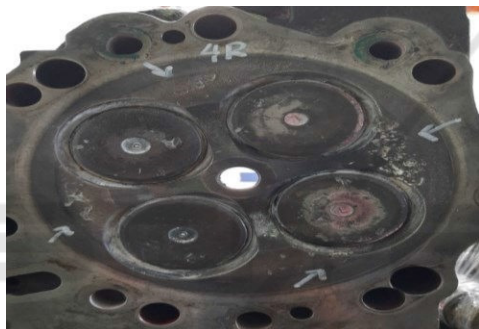
In this step a visual inspection of the combustion area should be carried out to check for damage and erosion. Erosion of these areas will have a negative effect on engine performance. Checkpoints for erosion are shown in Figure 10. Check areas that are suspected of being damaged and eroded, namely: (16) firering (combustion chamber area); (17) seating area; (18) the area between the injector nozzle orifice and the valve seat. Erosion in other areas of the surface may occur but will not affect the operation of the machine.

During the cleaning process, components were found to be damaged each surface of the combustion chamber on the cylinder head. The characteristics of the damage indicates that there has been "erosion" on the surface of the combustion chamber, erosion on the surface of the combustion chamber due to air bubbles that burst or explode during the power stroke of the engine's four stroke cycle. Erosion is characterized by a surface with small holes.

When these bubbles enter an area of high pressure, they burst (explode inward) sending a "beam" of liquid hitting the metal surface at supersonic speeds. Minor cracks sometimes occur and coalesce until a small part of the metal particles is released and results in holes in the component.

Deep pitting/pitting on the liner surface is the result of cavity erosion damage accumulates in one area of the liner wall only. The facts at the time of revelation stated that the damaged area was located between the cylinder head and the liner surface.

The aluminum housing of the cooling system can be damaged by cavitary erosion, especially if there is obstruction in the intake/inlet line which results in a low pressure and subsequently cavitation of the fluid in the pump impeller. Bubbles (bubbles) formed on the low pressure side (suction/suction) will burst on the high pressure side (exhaust/exhaust). Figure 10 shows erosion on the cylinder head.

Figure 10: Erosion on cylinder head.

1. Analysis of the 16 cylinder heads of QSK 50 MCRS shows that all cylinder heads can still be reused, because the cylinder heads are still within the standard range that has been set in the manual.
2. For longer cylinder head use, it is better to prevent more fatal damage by performing regular servicing. Therefore, in the assembly process and maintenance of the cylinder head is important and in the assembly process must be in accordance with the procedures set out in the manual.
