Analysis Performance Evaluation of Measuring Building (BM1) and Cipoletti (BM3) Buildings in the Mambal Irrigation Network of the Ayung River Irrigation Area

I Made Budiadi, Made Mudhina, Ketut Wiwin Andayani, Igag Suryanegara and I Wayan Wiraga
Department of Civil Engineering Bali Sate Polytechnic, South Kuta, Bali, Indonesia

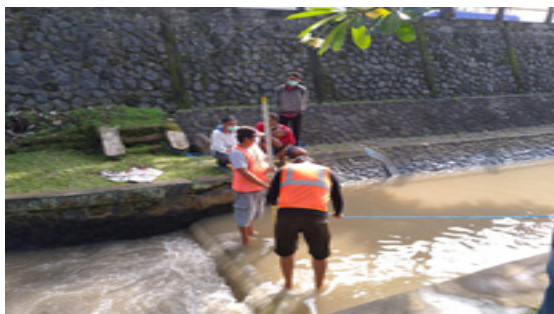
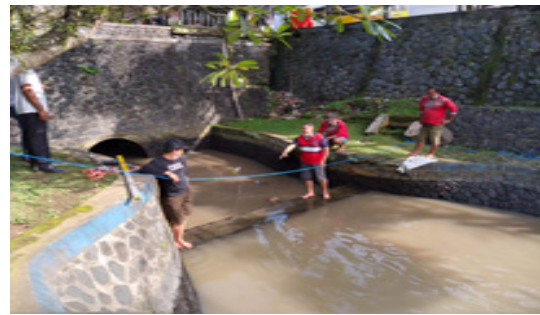
Figure 3: Measuring building BM1.

The building measuring the width threshold and Cipoletti in the Tukad Ayung irrigation area at the Mambal weir drainage condition has undergone many changes in shape as a result of the condition of the building undergoing several changes such as cracked walls, rusted sills and the presence of sediment upstream and downstream of the building. measuring. As a result of this condition, it is felt that there is a mismatch of water distributed to farmers' fields. This situation has a direct effect on the decline in optimal growth of rice plants which can reduce grain production at the farmer level. Condition. From the preliminary research conducted,

The Measurement Building DI Mambal is located in two locations, namely in Kapal BM1 Village. and BM3. In general, the condition of the building is very well maintained and can operate well. The problem, in general, is the presence of sediment in the channel which affects the flow. This sedimentation is caused by the remnants of the building downstream which enter the channel causing disturbances upstream. A complete picture of the condition of the building can be seen in the image below.

This measuring building is in the form of a wide threshold with a masonry construction with a plunge downstream as shown in Figure 3 below:

From the analysis results, the magnitude of $Cd \times Cv = 0.839$ is obtained so that the calibration of the old formula $Q = 1.71 B h^{0.5}$ becomes the new formula as follows: $Q = 1.705 Cd Cv B h^{3/2}$, so that it becomes: $Q = 1.705 \cdot 0.839 B h^{3/2}$ or $Q = 1,430 B h^{3/2}$

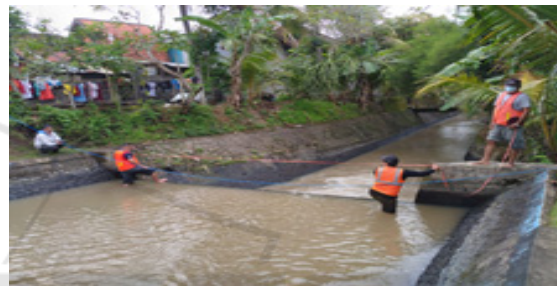
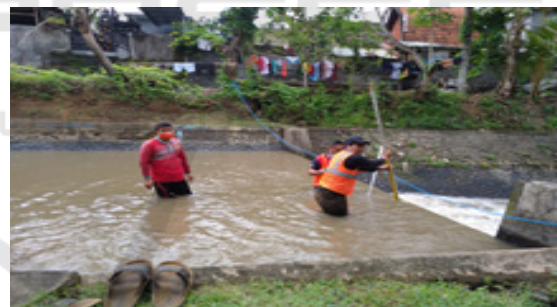
Figure 4: Measuring Building BM3.

Building Measure BM3, This measuring building is a cipoletti measuring building whose threshold is a sharp threshold made of steel. More details can be seen in Figure 4 below.

By entering the value of $2g \cdot 0.5$, then $Q = 2.95 Cd b h^{3/2}$ based on the results of the analysis obtained a cd value of 0.604 so that the new formula is obtained as follows $Q = 1.78 b h^{3/2}$
