# Study on Crack Leakage of Aircraft Hydraulic Pipeline

**Keywords:** Aircraft Hydraulic Pipeline, Crack Leakage, Maintenance Strategy.

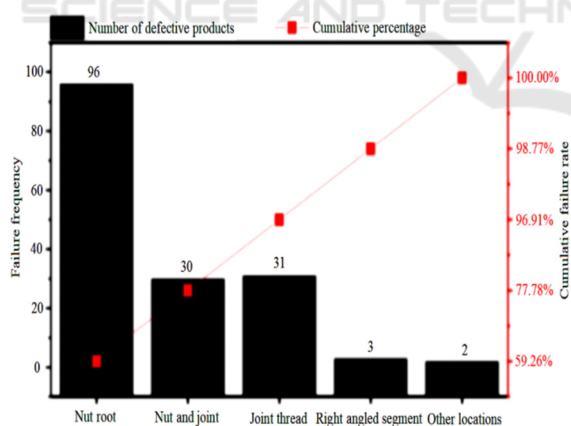
The occurrence of problems can be described as diverse and complex. According to the statistical chart of oil leakage locations as shown in Figure 1, the oil leakage at the root of the nut accounts for 59% of all oil leakage locations. The root of the nut is the location where the nut contacts the flat nozzle. It can be seen that the contact between the nut and the pipeline is the main problem of oil leakage at the joint with lock nut (Chen, 2021; Du et al., 2021).

Figure 1: Statistical Diagram of Oil Leakage Location.

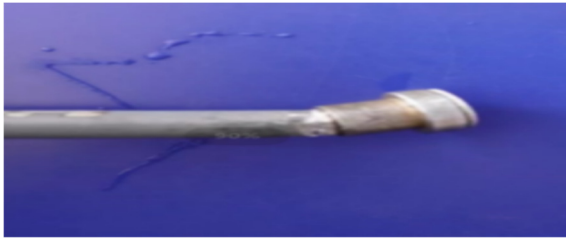
sleeve. Figure 2 shows the internal morphology of high circumferential cracks.

Figure 2: High cycle crack at sleeve root.

The reason for the crack at the root of the flat nozzle is that there is a stress at this position, which causes the extrusion between the pipeline and the flat nozzle. In addition, the aircraft will generate vibration during flight. The two factors act at the same time, causing the abrasion of the pipeline and eventually leading to the breakage of the pipeline.
