# Failure Analysis of the Fluorine Rubber Sealing Ring Used in Acidic Gas Fields

**Abstract.** The failure of fluorine rubber sealing ring occurs when it is used in the sulfur condition after one year. By visual observation, there are some cracks and the color changed to black from brown near the location of the contact delivery medium. In order to identify the cause of the failure, the physical properties, structure and composition were tested and compared with the same batch of the rings but without using. The results showed that the hardness and density of the material were increased because of gas permeation. It is evidenced by the microstructural observation, which shows that there are holes in the material near the transport medium. The specimens were characterized by FT-IR and XPS, respectively. The results show that the three-dimensional network structure of the ring is destroyed and the peak strength of -CF<sub>2</sub> and -CF is weakened while the CH<sub>3</sub>, -CH<sub>2</sub> and -C=O increase by the action of external stress and gas permeation. As a result of comprehensive evaluation, the reason of sealing ring failure is fatigue aging during the long-term service li

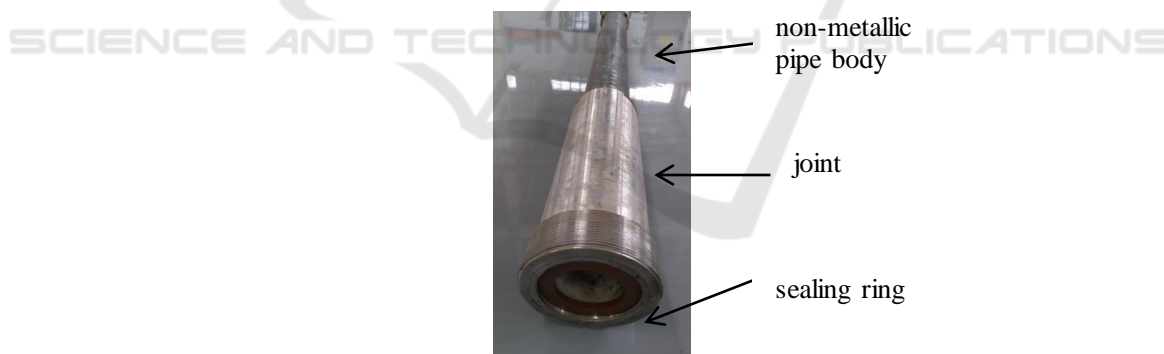
Non-metallic pipe (DN80 PN16MPa), as is shown in Figure 1, was used for oil gathering and transportation in sour oil and gas field. The transmission medium is mostly gas, with a small amount of oil and water. The pressure and temperature of transmission medium are 8.9MPa and 35 °C, respectively. The content of  $H_2S$  is 51800mg/m<sup>3</sup> while  $CO_2$  of 3.80mol%. The whole construction project had been completed on April 2015, while the pipeline had been started to use on May 2015. After running for half a year, the inspection of pipeline application effect was carried out. The result shows that the fluorine rubber sealing rings have failed with cracks and color changed shown in Figure 2. Meanwhile, new sealing rings produced in the same batch were also collected for comparison.

**Figure 1.** Structure of non-metallic pipe.

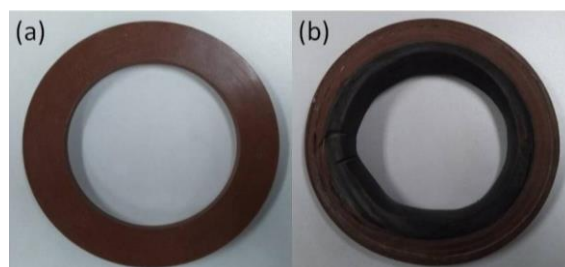
**Figure 2.** Macro morphology of (a) the new sealing ring and (b) used one.

It can be seen from Figure 2 that the color of the used sealing inside changes from brown to dark obviously, while the outer color is not changed. Compared with the new one, the color changed border of the used sealing ring is at a third place from inside to outside. Moreover, we can easily find by visual observation that the color changed border have some cracks, also in the black area. We can also find that it has an obvious squeeze traces in the sealing ring surface, and the thickness decreases from 7.72mm to 6.54mm, approximately.

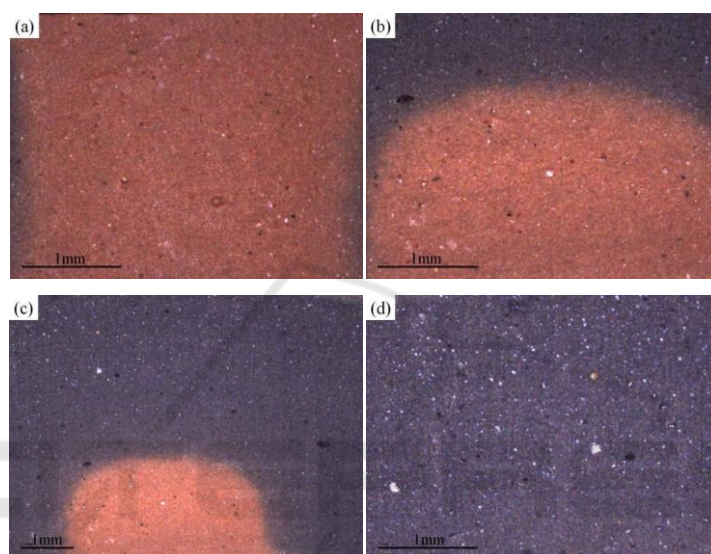
For researching the microstructure of the invalid sealing ring, the optical microscope was used to characterize the structure. From the Figure 3, we can find that the color of the sealing ring used for half year changed from brown to black partially and obviously.

**Figure 3.** Optical microscope of the sealing ring used for half year.

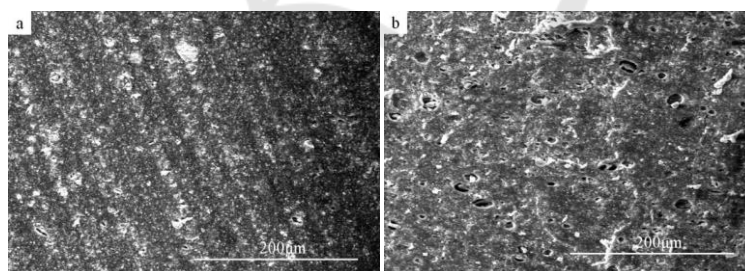
For further research, scanning electron microscope was used to characterize the microstructure. There are some micrometer grade pore in the used sealing ring (seen in Figure 4 b), compared to the new one (seen in Figure 4 a). The arising pores are resulted from gas permeation.

**Figure 4.** SEM of the sealing ring (a) the new one; (b) the used one.

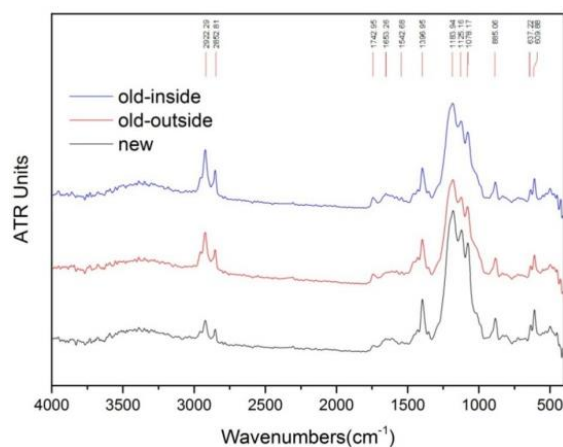
**Figure 5.** FTIR of sealing ring.

Through the tests (Figure 5), the results show that the old ring absorption peak is close to the new one, but the absorption intensity is different. It can be seen from Figure 5 that the absorption intensity of  $-\text{CF}$  and  $-\text{CF}_2$  decreases while the absorption intensities of  $\text{CH}$ ,  $\text{CH}_2$ ,  $\text{CH}_3$  and  $\text{C}=\text{O}$  increase with the service life of the fluorine rubber seal ring increasing. During the aging of the sealing ring, the position of the unsaturated bond in the rubber molecule is oxygenated to  $\text{C}=\text{O}$  structure. On the contrary,  $-\text{CF}$  and  $-\text{CF}_2$  bond strength decreased, indicating that  $-\text{CF}$  and  $-\text{CF}_2$  bond breakage and recombination, which lead to the degree of branching increase, eventually. That is the reasons why the  $-\text{CH}$  group absorption intensity increase. Therefore, the cause of failure of fluorine rubber seals is due to molecular breakage and cross linking.

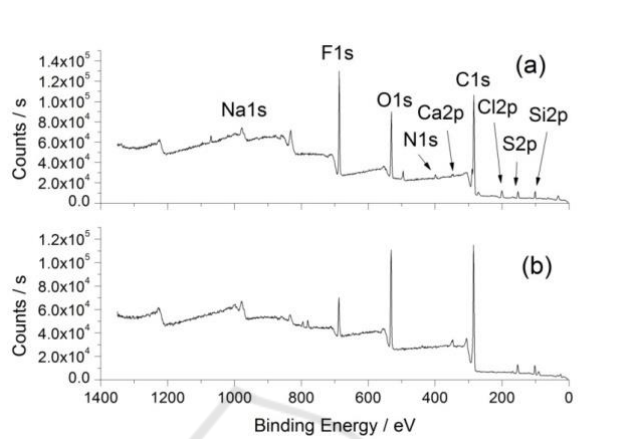
Elemental ID and Quantification of the new and the used sealing ring are shown in Figure 6. It is seen obviously that the element exist in the rubber mainly include Si, S, O, C and F. The trace additives such as Na, Ca, Cl and N not be investigated in this study. By comparing the elemental quantification of two rings (in table 2), the content of O and C element increase, with the percent content of atomic (at. %) from 13.82 to 19.25, 59.91 to 64.94, respectively. Contrarily, the content of F element decrease with the percent content of atomic from 14.34 to 7.11, the elemental F peak of both used and new rings counts to binding energy relation is shown in Figure 7.

**Figure 6.** XPS analysis of (a) used sealing ring and (b) new one.

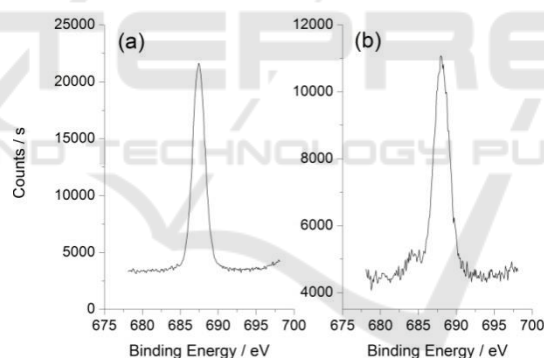
**Figure 7.** F1s scan in (a) the used sealing ring and (b) the new one.
