Study on Intermittent Failure Phenomenon of the Automotive Environmental Light Sensor

Abstract: According to the failure or intermittent failure of the FC-3AB ambient light sensor that feedback from the production site of Geely Automobile, the vehicles in this condition were tested and it is found that after the key hits the ignition lock ON file and switch the AUTO file, ark light environment (palm cover sun sensor) lights automatically open function is failure. When the car headlight is turned on manually, the headlight can be turned on, indicating that there is no problem with the car headlight. In this paper, the factors that cause the failure are collated and analyzed, and the fish bone map is drawn. Through the analysis of the quality of the ambient light sensor and the analysis of the process steps, it is determined that the solution is to seal the sensor assembly to ensure that the internal circuit of the shell does not fail due to moisture, the headlights of the car can be turned on normally, and the light in the car can be automatically adjusted. Eventually, the correctness of the solution is verified through experiments, and the failure rate of the automotive ambient li

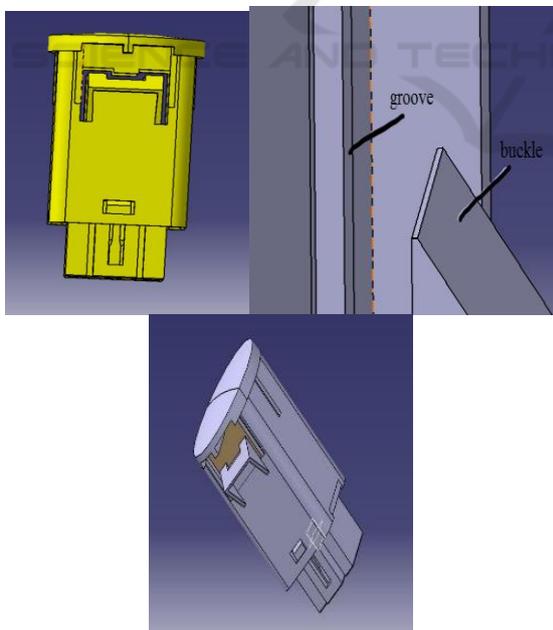
Figure 1. Comparison of models before and after improvement.

As shown in Fig.1 (a), there is no gap in the buckle part of the shell to prevent the water vapor from entering, but the buckle cannot be recessed when under pressure, so the sensor assembly cannot be easily installed in the car. If a large pressure assembly is used, it may crack the sensor housing and cause water vapor to enter. It is planned to set an impervious groove in the location of the buckle. Before drawing the groove, the dimensions of the buckle and the shell should be analyzed. In the modeling process of the original part mentioned above, the shell thickness is defined as 1.05mm, and the buckle height is 3.6mm. Suppose the groove depth is defined as 1.0mm, the sensor assembly moves the distance of the buckle to the inside when assembling, which is 1.0mm, making it difficult to assemble. Therefore, to increase the depth of the groove, the inner wall of the shell should be thickened. The improved design is shown in Fig.1 (b) and Fig.1 (c).

(a) Fault component model, (b) The design of the grooves, (c) Improved model

Because the size of the base is designed according to the outline of the bottom of the shell, there will not be too large gaps in the assembly. Sealing performance, in order to guarantee the assembly requirements shell and base are assembled on the base of the surface coated with sealant, if adopts the integration of welding seal due to the welding quality is not controllable, can cause there is not roa (Zhang cao, 2008), and the price of this product is very low ambient light sensor, when the sensor in the cause of the problem, only need to replace the sensor, so apply sealant is appropriate.
