Analysis and Research on the Fault Phenomenon of Car Sunroof

Abstract: Car skylight in view of the after-sales returns, customer site failure problem analysis, found abnormal closed, out of sync, sound and sealing strip fracture phenomenon, put forward by means of structural optimization and process optimization improvement scheme, according to the design parameters of automobile skylight components, through the corresponding module of 3 d software to complete the mechanical group of 3 d model before and after improvement. The rationality of the improved mechanical group was verified through experiments, and the fracture of seal strip was emphatically analyzed to verify the rationality of the improved scheme

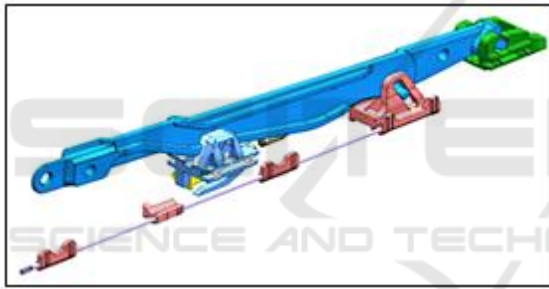
Figure 1. Old mechanical group structure diagram: guide block.

According to the material analysis, it can be determined that the reason is the friction between the soft shaft and the bottom of the front beam caused by deformation and pressure. As a result, the soft shaft can't be fully integrated with the gear when it turns to the gear, and the car sunroof can't be closed normally after a long period of rotation, which is not synchronous and abnormal sound. Analyze the reasons for the failure: failure to comply with the inspection standards, problems in the production process of workers, unreasonable structure of product design.

With digital multimeter and electronic tension meter to the structure of physical test, on the soft shaft collected old and without the use of soft shaft bending resistance numerical tests before and after comparison, table 2, it can be seen without bending soft shaft new pieces after bending resistance than soft shaft after bending to an old piece of resistance value, so that the soft shaft deformation resistance is too large, need to review the complete product structure.
