# Shore Protection Structures on the Coast of Biduk-Biduk District, Indonesia

Tommy Ekamitra Sutarto <sup>a</sup>

Department of Civil Engineering, Politeknik Negeri Samarinda, Jl. Ciptomangun Kusumo, Samarinda, Indonesia

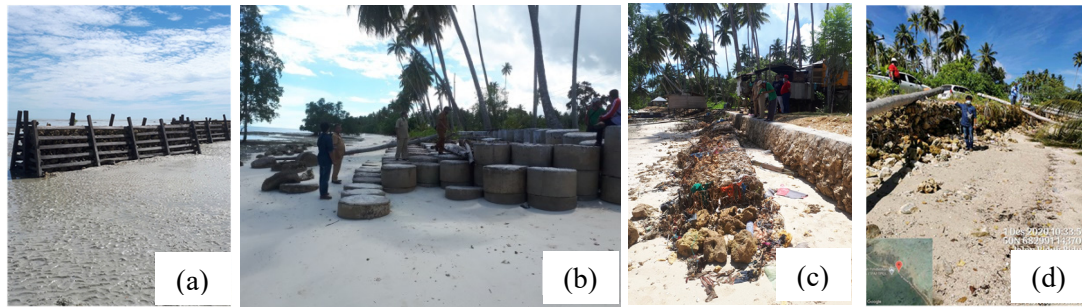
Figure 3: Simple coastal protection structures on the shoreline of Biduk-Biduk: (a) breakwater, b) concrete-ring revetment, c) rock revetment, d) gabion.

Simple shore protection structures such as breakwater of wood and stone (Figure 3a), concrete-ring revetment (Figure 3b), rock revetment (Figure 3c), and gabion (Figure 3d) were constructed in order to control the rate of abrasion in several locations. However, most of the structures failed to fulfill their functions. In some locations, structural failures can be observed (Maryadi et al., 2020).

Apparently, existing structures were designed based on modest common practices without support from sufficient data and engineering analysis. The breakwaters (Figure 3a) were unstable and experienced frequent overtopping especially during the occurrence of spring tide coincided with strong winds. This condition typically occurs in April.

Implementation of concrete-ring revetment (Figure 3b) brought spatial and aesthetic issues into attention when considering future plan for Biduk-Biduk as a tourist destination. Rock revetments (Figure 3c) also experiences frequent overtopping. Instead of absorbing wave energy, these structures created wave reflection capable of eroding the shoreline. Similarly, the existing gabions (Figure 3d) were commonly failed due to corrosion that damaged their wires.

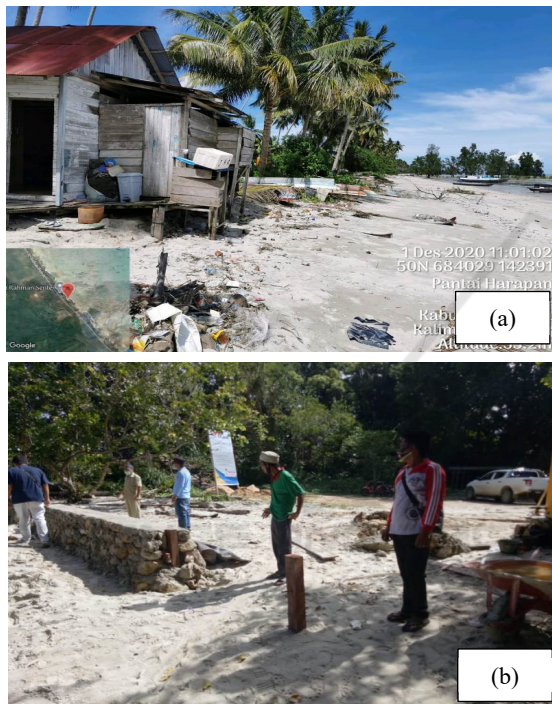
Figure 2: Wave-induced abrasion threaten the existence of nearby facilities such as: (a) houses, and (b) roads.

abrasion. This phenomenon has threaten the existence of nearby houses (Figure 2a), motels, roads (Figure 2b), and other public facilities (Maryadi et al., 2020). In a periode between 2009 and 2019, the retreat length was 4 to 5 m in Pantai Harapan Village and 5 to 6 m in Biduk-Biduk Village (Maryadi et al., 2020).

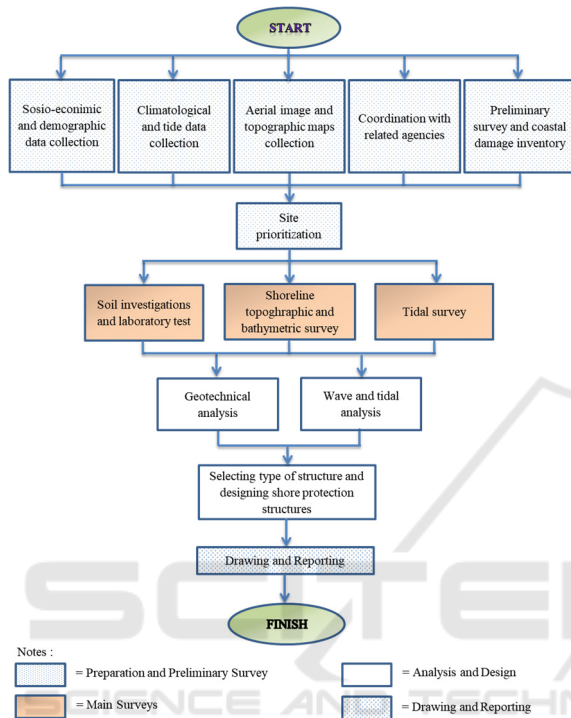
Figure 4: Study procedure.

This study was performed in 4 (four) stages, i.e.: 1) preparation and preliminary survey, 2) main surveys, 3) data analysis and detail design, and 4) drawing and reporting. Each stage consisted of several activities as outlined below (Figure 4).

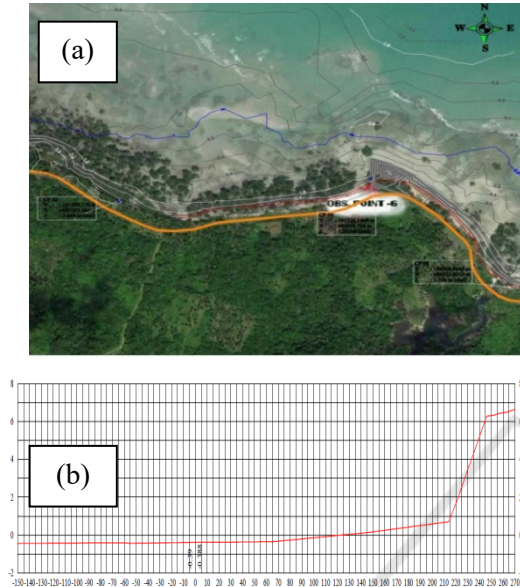
Figure 7: Results of topographic and bathymetric surveys at Pantai Harapan Village (point 6): (a) contour, (b) typical cross-shore profile

Topographic and bathymetry measurements were performed on the shore and nearshore zone in Pantai Harapan Village (observation point 6). Topographic measurement was conducted 50 m from shoreline toward hinterland using real-time kinematic global positioning system (RTK-GPS) (Figure 6a), while bathymetry measurement was performed 400 m from the shoreline toward the sea using echosounder GPSMap 580/585 (Figure 6b and 6c). The contour map for the measured area in shore and nearshore zones were presented in Figure 7a. Also a typical cross-shore profile could be seen in Figure 7b. The beach slope was typically mild, ranging from 1 to 3 %. The beach slope was typically mild, ranging from 1 to 3 %. Beach material composition was dominated by white fine sand with less coarse sand. A little portion of coral reef fragments were also found in some locations. Typically, beach sediments

For design purpose, the following data, obtained from previous survey and analysis, were summarized here. High Water Spring (HWS) = +1.55 m (MSL), Mean Sea Level (MSL) = +0.00 m, Low Water Spring (LWS) = -1.46 m (MSL), beach slope,  $m = 0.033$  (Figure 7b), design-wave height,  $H_o = 3.61$  m (25-year wave), design-wave period,  $T_o = 11.44$  seconds, dan beach floor elevation = +0.8 (MSL) (Figure 7b). The core material for the seawall was cyclopean concrete consisted of 60% concrete and 40% local stone, while the surfacial material was 20 cm-thick reinforced concrete slab ( $f'c = 26.4$  MPa) (Figure 10).
