# The Implementation of D155A-2 Bulldozer Steering Overhaul

Al Amin, Halman and Andreal Imran

*Heavy Vehicle Study Program, Nunukan State Polytechnic, Jl. Ujang Dewa, Nunukan, Indonesia*

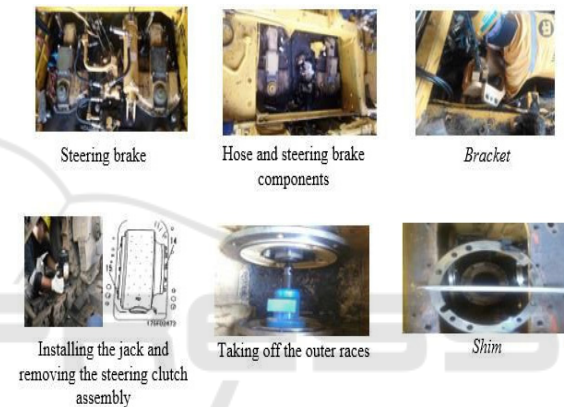
points by marking the location on each component with the RH and LH mark. Marking aim is to make the installation process easier. The next then remove the chord rod that is inside the steering brake cover so that the cover is detached from the bracket, and remove the brake booster assy. Use a rope or sling that is physically small but strong to lift the bracket and steering clutch assy, lift it with the help of a crane (same RH/LH parts), then remove the steering clutch assy and remove the bavel gear shaft assembly. Next, pay attention to the shim on the edge of the signpost or the right and left sides. After the removal work is complete, close the steering case so that dirt and other objects don't get in, and then wash all the components of the steering brake so that the disassembly process is easy (Figure 1).

Figure 1: Remove steering brake.

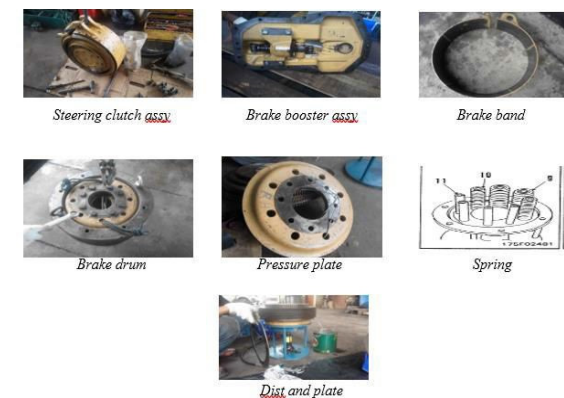
The disassembly process is carried out carefully, which will be disassembly of the brake booster assy, cleaning and then washing components. After that disassembly steering clutch assy, then the critical point is "this process must be done carefully because the spring has a large enough strength, about 200kg large spring, 150kg small spring". The process is carried out carefully (Figure 2).

Figure 2: Disassembly steering brake.

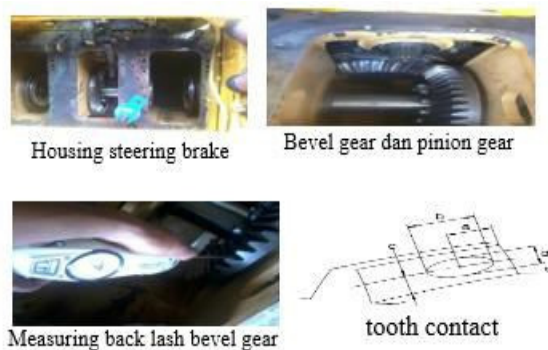
that the bevel gear center. Then tighten the bolt mounting outer races and install or tighten the bolt mounting bavel gear by using special tools and the same method when removing, after that clean the steering brake housing until it is completely clean (because the housing is where the oil is) so that the oil is not contaminated, and also Clean the transmission bavel gear and pinion gear for measurement. Perform measurement acklash on the bavel gear (Figure 5).

Figure 5: Install bever gear.

Based on the results of the inspection and measurement of the overhaul activities above, several damaged components must be repaired or replaced. The possibilities that cause damage to these components must also be known, so that preventive measures can be taken so that they can extend their service life and minimize expenses for component repair or replacement. These components include: (1) the dist and plate have scratches and dents which are most likely caused by the steering oil being contaminated by grams from the friction of objects that come into contact in the steering case. Even though at the time of measurement it was still within the standard limits, but because of these defects, the dist and palte components had to be replaced because it could result in not optimal steering performance; (2) The inner drum has a fairly severe crack which is most likely due to the unit undergoing heavy work or it could be due to the age of use that has passed the standard limit and must be replaced; (3) The brake drum lining on visual inspection of the brake drum lining already looks thin and it can also be seen from the historical unit that the canvas has never been replaced, so that during this overhaul, the lining must be replaced; (4) Tooth on the bavel gear at the time of measurement is still in good condition because the contact points made at the time of checking are still within the standard limits, as well as measurements on the backlash are still within the standard limits, so that the bavel gear can still be used; (5) the oil pressure measurement shows that the steering and brake

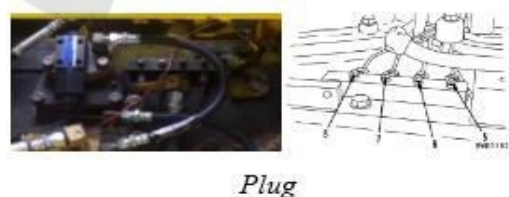
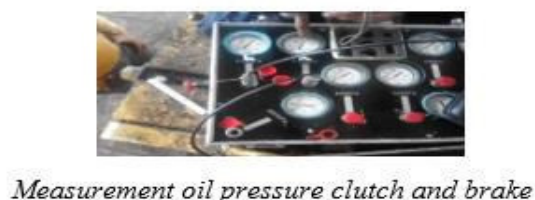
The fourth process is to install the steering brake. This process is done by cleaning the steering brake housing, then attaching the steering clutch assembly to the housing. After that, the steering clutch (RH, LH) was measured. Then install the right and left side mounting bolts and tighten them, and also install the bracket, brake booster assy, attach the pins, connect the small host that is on the brake band. After that, adjust the steering brake on the spring assist brake, then install the steering brake cover and torque bolt, then fill in the steering oil for testing and adjusting (Figure 6).

Figure 6: Install steering brake.

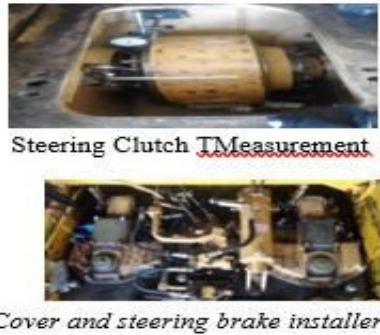
and measuring the oil pressure (Figure 7). Then the last process is replacing the filter and strainer. Previously the filter had not been replaced due to flashing the impurities contained in the new components, after which the filter and strainer were replaced after a test run (Figure 7).

Figure 7: Testing and adjusting steering brake.

pressure has been achieved, so that during operation the unit will not experience trouble when turning and will not be held back when the clutch and brake work. Because when the pressure on the clutch and brake is not reached, it can cause a malfunction in the steering system.
