Building Calibration Analysis Measure Ayung River Irrigation Area Case Study of Kedewatan Dam

I Nyoman Anom PW, Made Mudhina, I Gusti Lanang Made Parwita, I Nyoman Sedana Trinadi
and Yuliana Sukarmawati

Department of Civil Engineering Bali State Polytechnic, South Kuta, Bali, Indonesia

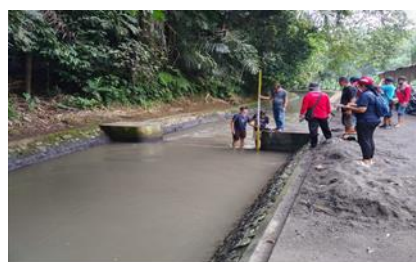
Figure 1: BLG 1.

Pictures of the current condition of the building can be seen in the figure 1.2 and 3.

There are six measuring buildings in the Kedewatan dam which are spread over the irrigation network. Kedewatan irrigation area Measurement Buildings are located in six locations, namely in Kedewatan Village BLG 1 (left), BLB 1 (right), BLK, BLM, BS1 and BS3 in Lambing Mambal Village. In general the condition of the building is very well maintained and can operate well. The problem in general is the presence of sediment in the channel which affects the flow. This sedimentation is caused by the remnants of the downstream building that enter the channel which causes disturbances upstream.

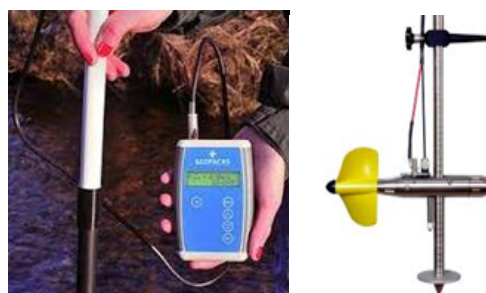
The current meter is the main tool used to measure the speed of water in meters/second.

Figure 7: Current meter (source: Seba Hydrometrie).
