Identifying the Impact of Human Made Transformations of Historical Watercourses and Flood Risk

Thomas Moran¹, Sivaraj Valappil¹ and David Harding²

¹*Waste Innovation – Thames Water Utilities Limited, Island Road, Reading, U.K.*

Keywords: Geographical Information System, Lidar, Culvert, Watercourse, Digital Terrain Model, Sewer, Flood.

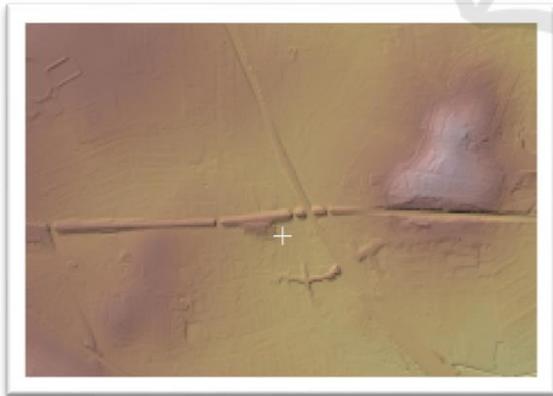
Figure 2: Cuttings and embankments in the EA DTM.

The data is supplied in ESRI ASCII format (.asc files) in 10km by 10km tiles. These were converted in Quantum GIS (QGIS) to ERDAS IMAGINE format (.img files) and mosaicked to form a seamless dataset over the study area. This data was run through an automated drainage extraction routine in QGIS since the data is inherently noisy and a number of man-made features interfere with the natural drainage patterns (roads, railways etc.)

However, this is true of all DTM products. The full resolution 2m DTM was found to give a dense network of drainage, far too detailed for the purpose.

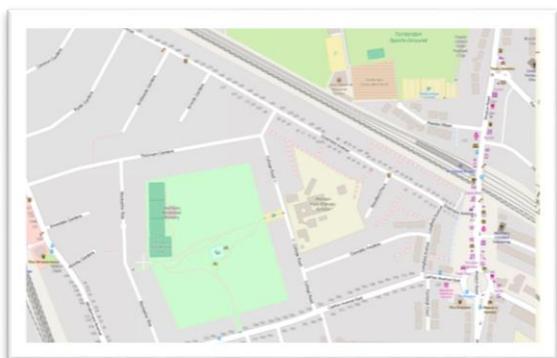
Firstly, here is the OpenStreetMap (OSM) data over an area in West London, where there is no trace of surface watercourses:

Figure 4: OSM of an area with no surface watercourses.

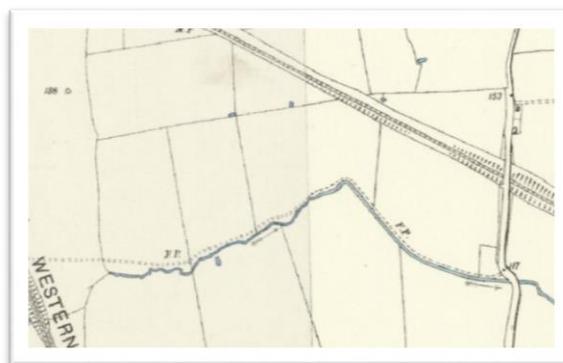
And this is what the same area looked like around 1900:

Figure 5: OS 1:10,500 Historical Mapping.

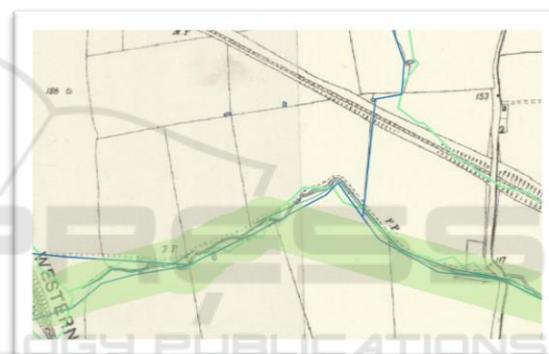
Now, the digitised drainage (blue line), the EA river buffer (green shading) and the drainage extracted from the EA LiDAR (green line) can be overlaid.

Figure 6: Overlay showing extracted drainage.

It is clear that the EA LiDAR drainage follows the river quite well, but the railway interferes with the drainage path. The EA main river network is mostly good, but it cuts a corner on the 1900 river path.

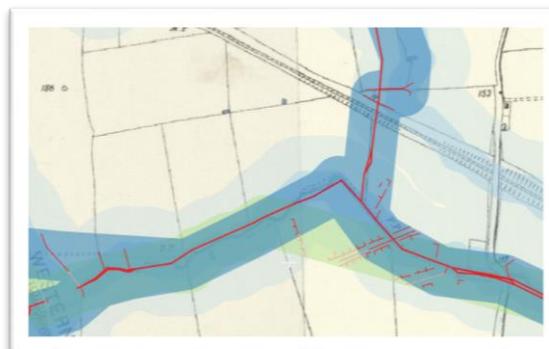
Figure 7: Overlay of drainage buffers and sewer network.

The large (>300 diameter) sewers (thick red line) in this instance provide a close match to the digitised drainage network, with the smaller diameter sewers not relevant.

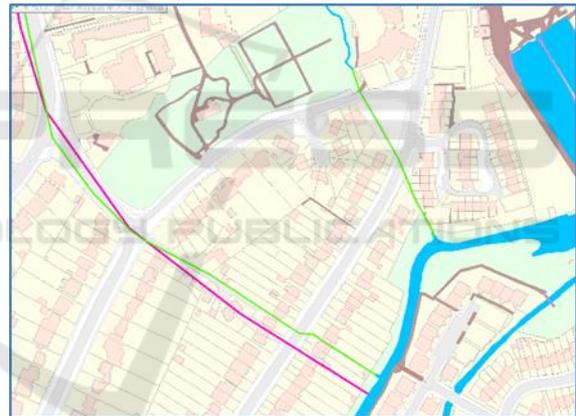
Figure 10: Example of highly likely culverted watercourses.

A sewer (green) connecting two watercourses (blue) or following closely to the digitised lost river (pink) were classed as “highly likely” if the diameter is greater than 600mm, or “possible” if between 300mm and 600mm.

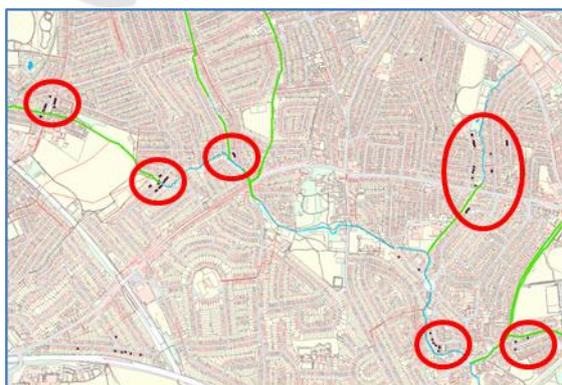
Figure 14 shows an area with hydraulic sewer flooding (brown points circled in red) due to culverted watercourses (green):

Figure 14: Example of hydraulic flooding due to watercourses.
