# Failure Analysis and Research of Washing Nozzle in Front of Automobile

**Keywords:** Front washing nozzle, Failure, Improved design, Finite element analysis.

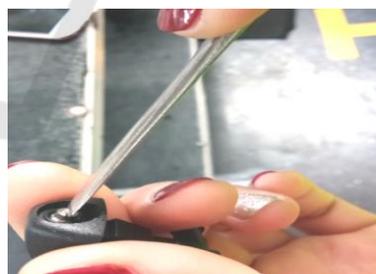
Figure 1. Nozzle regulating method.

Each major automobile giant has formed its own characteristic wiper washing system, which has advantages in reliability, economy or advanced technology (Li guoqing, 2017). The investigation found that xiangtan geely automobile production base before the emergence of automobile washing nozzle spray column spray problem, after inspection for the ball core fracture. After investigation, during the loading and production of this model, 7 front nozzles were found to be broken when the injection Angle was adjusted. According to the on-site physical investigation and fault reproduction, it is preliminarily determined that the interference amount between the nozzle body and the ball head is too large, leading to the fracture of the ball head during adjustment (product consistency problem). Interference fit is adopted between the nozzle body and the ball head, and the interference amount is 0.05mm.

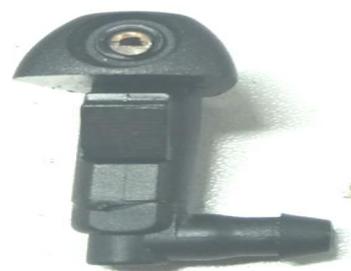
Figure 2. Failure parts.

After dismantling of the old parts and test analysis, confirm the main failure reasons might be: ball core fracture basic appear in the winter, the temperature decrease after the plastic parts of a contraction, the matching of the nozzle and the spool too tight, the user without the use of special debugging tools debug copper ball, caused the ball core fracture, this problem has become a problem to be solved in practical production, it has a strong production of practical significance.

After the dismantling and test analysis of the old parts, it is confirmed that the main failure reasons are as follows:

(1) The core fracture basically occurs in winter, and the plastic parts shrink after the temperature decreases in winter, which leads to the over-tight cooperation between the core and the nozzle.

(2) The root of the nozzle center groove is designed to be at right angles, and the strength is insufficient. Besides, users do not use special tooling for debugging, which results in the fracture of the ball core.

(3) The spraying Angle of the nozzle has been fully adjusted in the factory inspection, and our company used special tooling for debugging, without considering the possibility of some users adjusting the Angle of the nozzle.

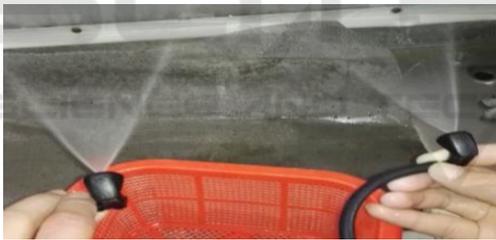
1. Spraying effect: there is no obvious deviation between the spraying effect and the change, as shown in FIG. 12.

Figure 12. Improved nozzle stress cloud diagram.
