# Analysis Damage Cylinder Head Engine on QSK 50 MCRS

Hamka Munir, Ismail Ramli and Misdar Alamsyah

*Nunukan State Polytechnic, Heavy Vehicle Study Program, Jl. Ujang Dewa, Nunukan, Indonesia*

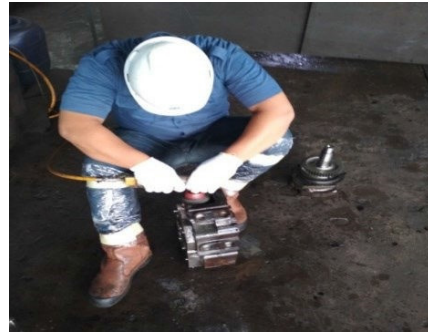
Figure 4: Inserting the cylinder head into the hot tank.

In this step the cylinder head will be cleaned of dirt/dirt adhering to the components and cleaned of rust and oil adhering to the cylinder head. Because the slightest will affect the results of the measurements later. Figure 3 shows the process of inserting the cylinder head into the hot tank to remove the remnants of dirt/soil, paint, rust. Shows the spraying process on the cylinder head and grinding process uses an air angle grinder with a steel wire brush.

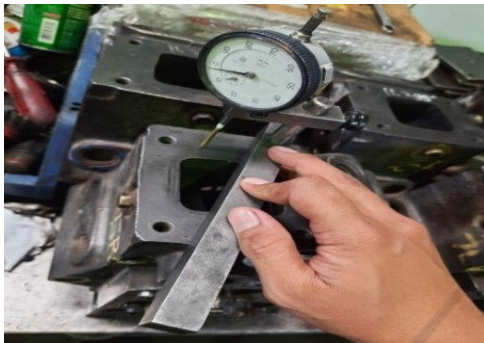
Figure 7: Pitting measurement on cylinder head.

High pressure and temperature in engine operation can cause changes in the shape of the cylinder head surface, usually in the form of indentations or depressions on the cylinder head surface. Therefore, it is necessary to measure the pitting cylinder head. This is to check the flatness of the cylinder head surface. Because the density of each combustion chamber in the cylinder head greatly affects the life and performance of the engine itself. If there is pitting on the surface of the cylinder head that occurs too far from the specifications, it will result in fatal damage, namely:

This measurement uses a dial indicator and a straight edge. The surface of the cylinder head that experiences high pressure and temperature is measured for flatness, then the measurement results will be compared with the standards in the manual to determine whether the cylinder head can still be used, requires repair or needs to be replaced with a new one.
