# Risk Factors Fall in the Elderly at Panti Werdha Sejahtera Banjarbaru

**Keywords:** anthropometry, spatial design, elderly, fall risk, safety

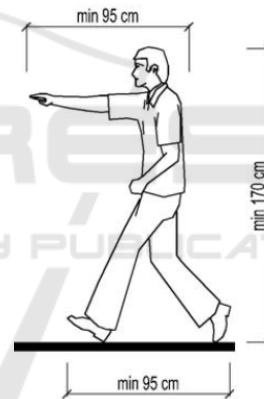
The result of anthropometric measure shows that the average height of respondents is different to the average height of Indonesian which is 170 cm as indicated in Minister of Public Works Regulation Number : 30/Prt/M/2006 on Facility Technical Guidelines and Accessibility in Building and Environment page 13 as followed:

Figure 1. Average height according to standard

The result of anthropometric measure show that the average height of male respondents is 149.6 cm and 138.9 cm for female residents. The result of the measure is shown in following table:
