Identification of Coastal Problem along the East Coast of Lampung Indonesia

Trika Agnestasia Tarigan¹, Nanda Nurisman¹ and Nirmawana Simarmata²

Abstract: The dynamics of nature occurring in recent years, as well as climate change and the increasingly severe pressures of humans have had a noticeable impact on the coastal conditions. This research aims to present the results of identification of various damages that occurred along the East Coast of South Lampung Regency of Lampung Province with the method of field surveys through observation, measurement, study of supporting data and previous research. This study was conducted with several activities, namely field observation, interviews and documentation of conditions for damage to coastal areas. The final result of this identification is to describe: (a) the type of damage occurring; (b) Cause of damage; (c) The impact of any damages incurred; (d) Alternative countermeasures; and (e) The location coordinates are damaged. The results showed that the sedimentation process and damage to coastal structures occurred at the location of Ketapang Laut village. Sedimentation also occurs in the estuary of Ketapang Laut village of South Lam

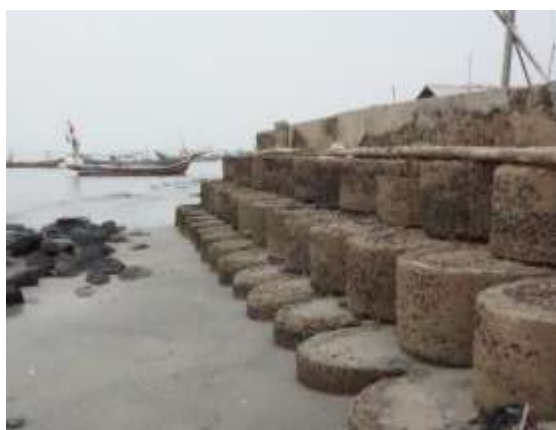
The process of sedimentation and damage to this coastal structure occurred at the location of Ketapang Laut village. The location of the sedimentation beach is one of the locations that belong to the East Coast region of Lampung province South Lampung and is located at the location of the coordinates $5^{\circ}44'26.05''$ S and $105^{\circ}47'48.21''$ E shown on Figure 2.

In addition to the sedimentation problem the field survey results also showed that the sedimentation process that occurs constantly causes damage to

Figure 2: Sedimentation and coastal structure damages.

coastal structure. This type of coastal structure is revetment. Revetment is a coastal structure that is built on coastline and is used to protect the coast of Dai wave attacks and runoff waves (overtopping) to the ground (Triatmodjo, 2012). Revetment has a sloped side and can be made from a pile of rocks or bronzes, making it more flexible and adapts to the scours at the foot of the building. The revetment that functioned as a coastal protective structure was damaged because of the buildup of sediment in the concrete pile that formed the presence of new land. If it is reviewed based on the characteristic of the east coast of Lampung province that has the same characteristics as the north coast of Java (Sulaiman, 2018) that the coastal area is characterized by the low slope of the mud and swamp overgrown mangrove and has a very fine grain size, it is very possible once the dominant sedimentation process occurs in this location. The condition of the beach with muddy characteristics is also very related to the wave energy is very low, but the tide is greater. Based on the results of the research conducted by Tarigan et al. (2020) that the East Coast of South Lampung has a characteristic wave height which ranges from 0.36 m-2.57 m. East coast of South Lampung Regency that has a character sedimentary mud affects the sediment process that tends to undergo sedimentation process in the coastal area (Tarigan et al., 2020).

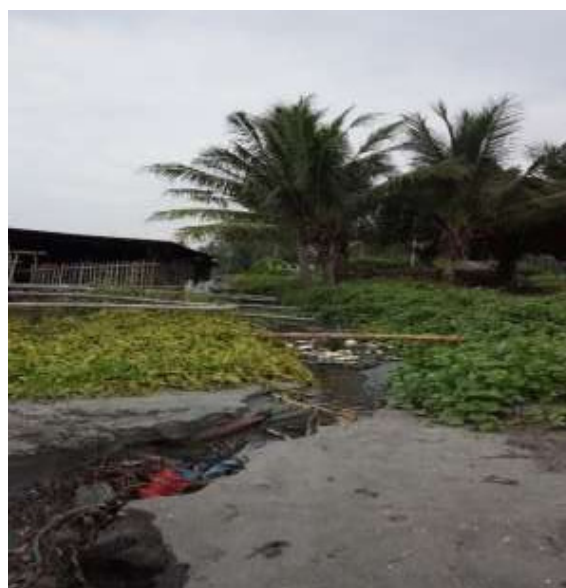
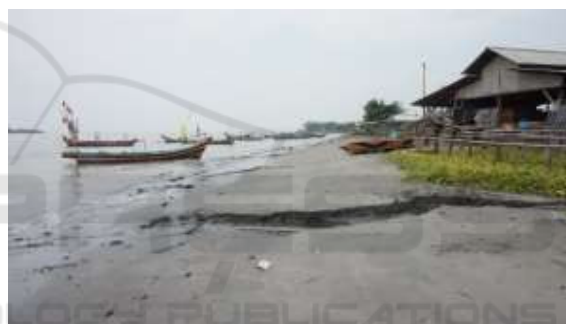
The process of in the village of Ketapang Laut South Lampung District, this led to the presence of land arising causing the increase of river estuary and the coastline. The ignition of the estuary that occurs can clog the stream, pollution, the fishing vessel traffic at low tide and on the other side when the tide can cause the widespread water over the bank.

People in the village of Ketapang Laut South Lampung District overcome the blockage of the river by doing simple dredging such as making a hole that

Figure 3: (a) and (b) Sedimentation.

functions to drain the flow of the river to the beach that shown on Figure 3(a) and Figure 3(b).

Based on the condition of the field obtained information that if not in the rainy weather conditions, the river discharge is relatively small so that the current speed is not able to erosion. The deposition to a clever consequence of the river estuary completely covered sedimentary deposits.

To solve the problem, it is necessary to do the treatment to take the entry of sediment to the estuary of the river. The bank's estuary management strategy can be determined where the sedimentation of the

river mouth is the simplest and least inexpensive alternative handling (Triatmodjo, 1999). Dredging can be done at the beginning of the rainy season, either by mutual assistance by local residents or by using the help of heavy equipment if possible in the way of inspection. To get the maximum flow, a large volume of dredging is required. The difficulty of this alternative is the re-enlarger groove that is completed scraped, especially when the wave with greater energy and also if the interval between the completion of dredging with the advent of the first flood is still long enough, so that the groove that has been dredge will be closed back by deposits. Triatmodjo (1999) states that when dredging is done by mutual assistance, the population can choose the thinnest and most narrow deposits to be scraped on downstream turns. The purpose is the River estuary remains turned, so the discharge capacity of the addressing is reduced.

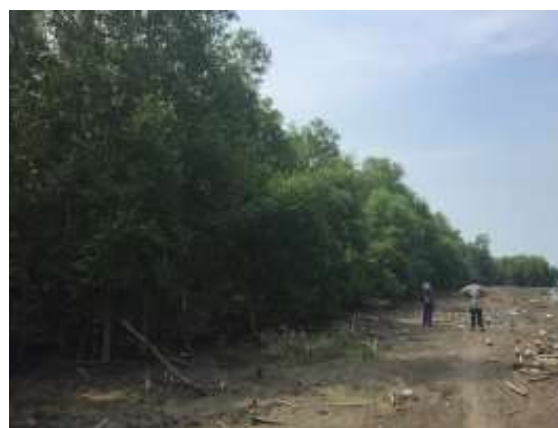
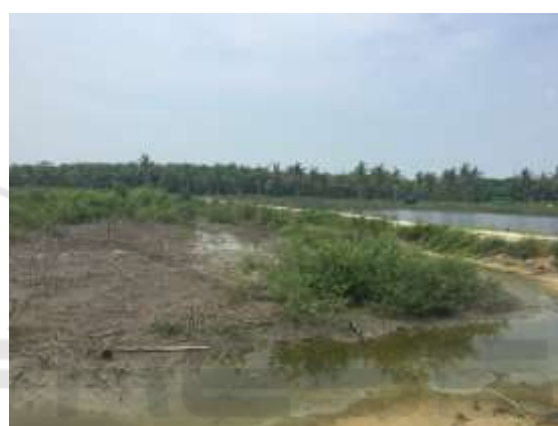
The decrease of mangrove forest land cover that occurred in the coastal area East coast of South Lampung district is at the coordinates of $5^{\circ}39' 48.76''$ S – $105^{\circ}48' 41.48''$ E. Based on the results of field surveys and interviews with local residents, one of the causes of damage to the mangrove forest is caused by the opening of the area to serve shrimp ponds. The field conditions taken in May 2019 are shown shown on Figure 4.

Based on the information quoted from previous research according to resource Atlas of Lampung coastal area (Wiryawan, 1999) coastal area along the coast of East Lampung except Way Kambas National Park occurs the change of land that initially swamp and mangrove forest into rice farming land and shrimp pond. The existence of mangrove forest covering about 81 percent of the beach in Lampung, can provide many benefits, both physically, biologically and economically. But excessive utilization especially on economic utilization can cause damage to ecosystems. However, if the land cover area of mangrove forest will be held continuously, it can cause impact on coastal area and beach.

Figure 4: (a) Mangrove forest area; (b) land conversion.

Some of the impacts that can occur are coastal erosion and river borders, sedimentation, environmental pollution, decline in ecological function that will affect the economic aspect especially for fishermen who are in the East Coast district of South Lampung Regency and will cause sea water intrusion. Policy recommendation to improve the mangrove ecosystem and reduce the impact is to rehabilitate the mangrove ecosystem by actively involving the community.
